# Site Team Evaluation Prioritization

L1110900002 - McHenry  
S. California Chemical  
R.D 059483081  
SE/IRS 9/16/99

## CERCLA Report

**Illinois Environmental  
Protection Agency**

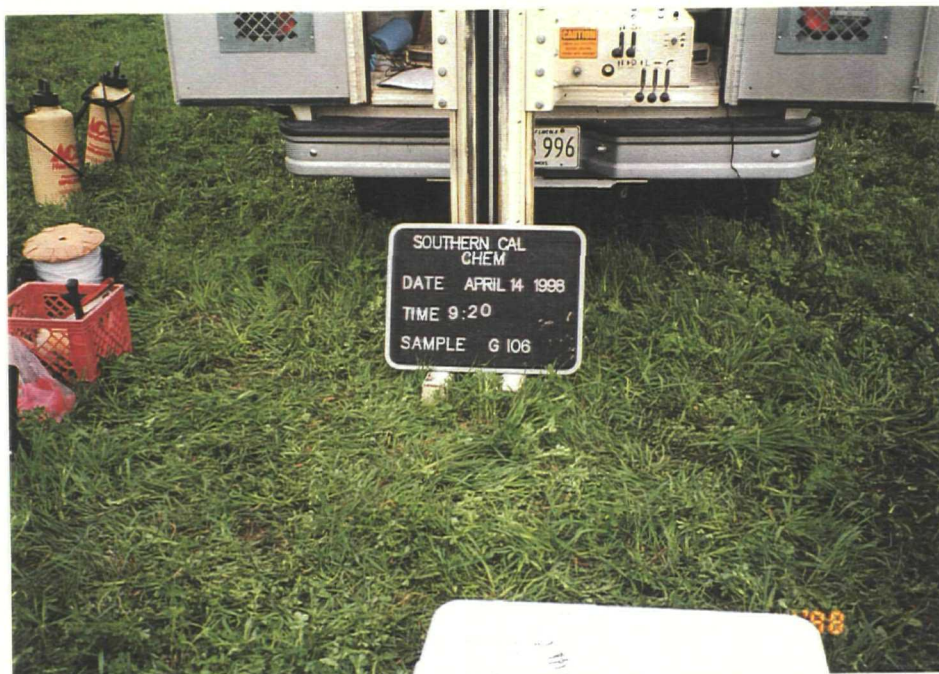
DATE: 4-14-98	SITE ILID#: 059483081     COUNTY: Mc Henry
TIME: 9:20	SITE NAME: S. California Chemical
PHOTOGRAPH TAKEN BY: R.Casper	
COMMENTS: Picture taken toward: South.	
Photo Number 1.	
Sample G106 was collected in the Techalloy hay field depth of 12 feet.

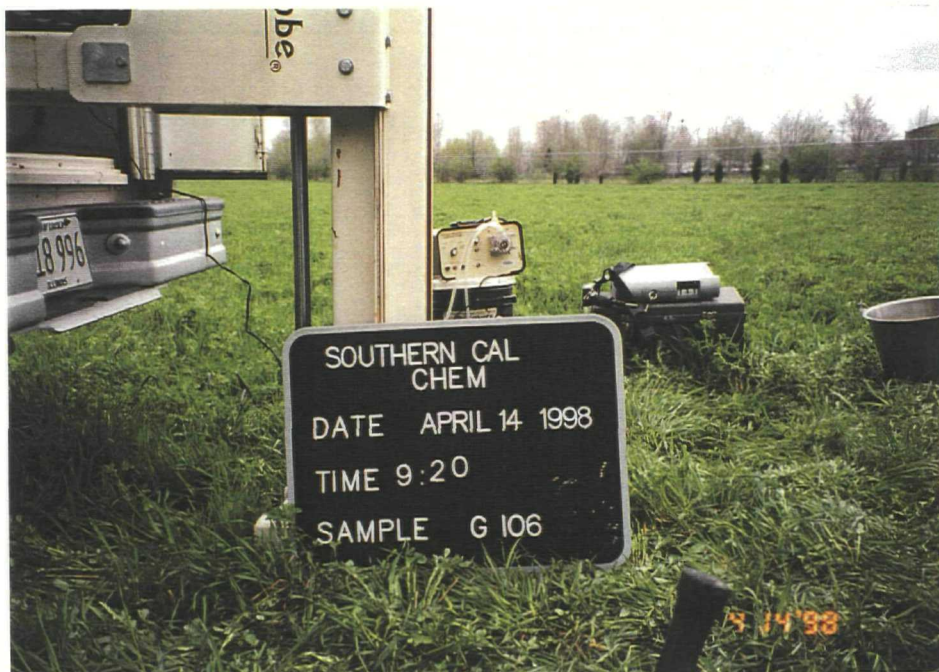
DATE: 4-14-98
TIME: 9:20
PHOTOGRAPH TAKEN BY: R. CASPER
COMMENTS: Picture taken toward: West.
Photo Number 2.
The fence in the background is the west property boundary of Union Evergreen School.

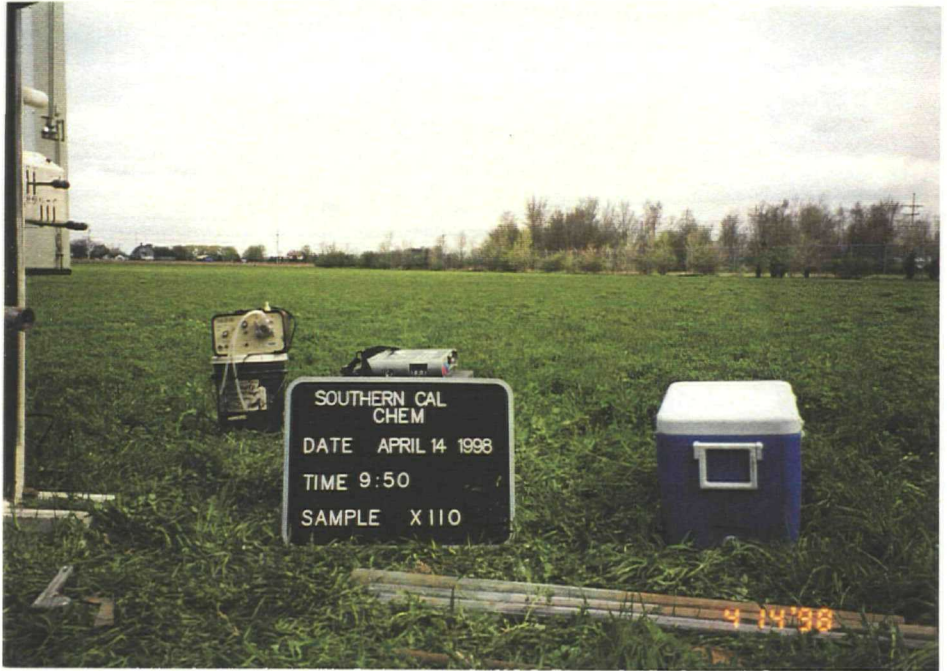
COMMENTS: Picture taken toward: South.	
Photo Number 3.	
Sample X110 was collected at the same location as	
G106 at a depth of 8 to 10 feet.

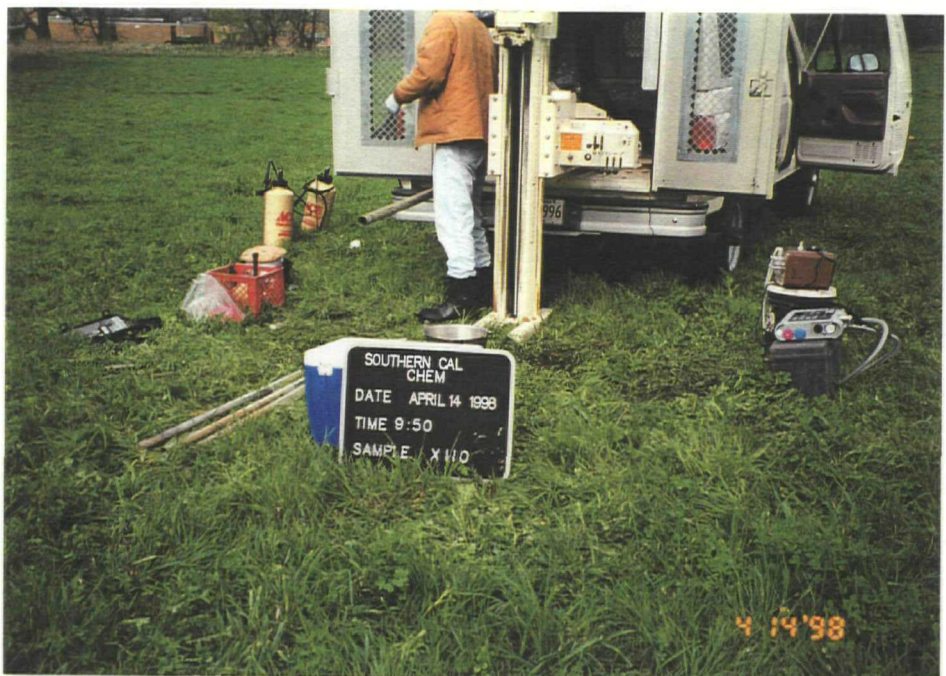
DATE: 4-14-98
TIME: 9:50
PHOTOGRAPH TAKEN BY: R. CASPER
COMMENTS: Picture taken toward: West.
Photo Number 4.
X110. The sample consisted of a
fine to coarse
sand.

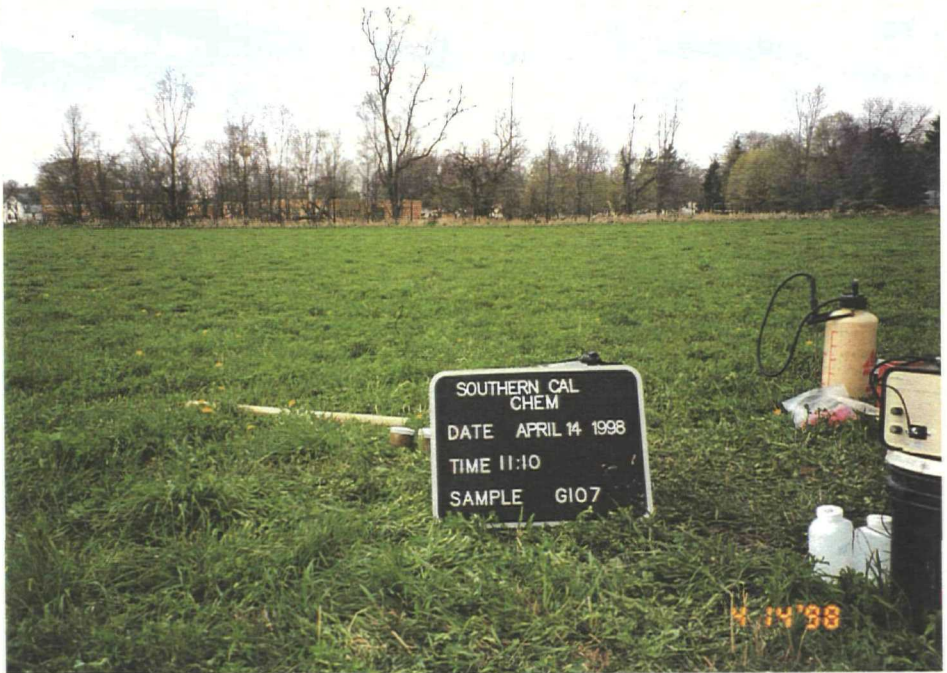
COMMENTS: Picture taken toward: West.	
Photo Number 5.	
Sample G107 was collected at a	
depth of 12 feet from a coarse sand and gravel.

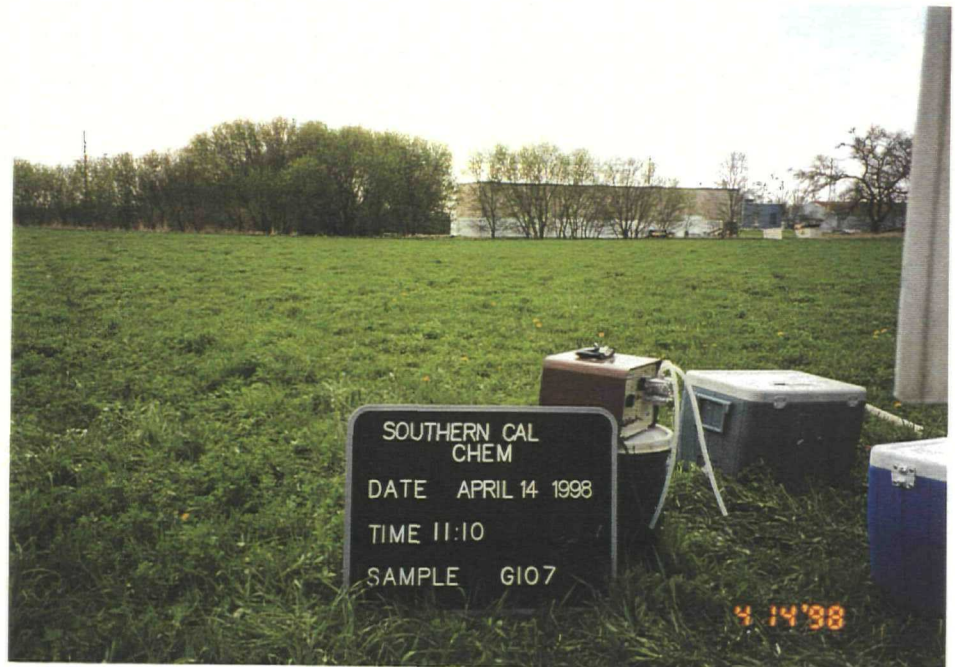
DATE: 4-14-98
TIME: 11:10
PHOTOGRAPH TAKEN BY: R. CASPER
COMMENTS: Picture taken toward: South.
Photo Number 6.
The building in background is a
company that makes
Bar-B-Q sauce.

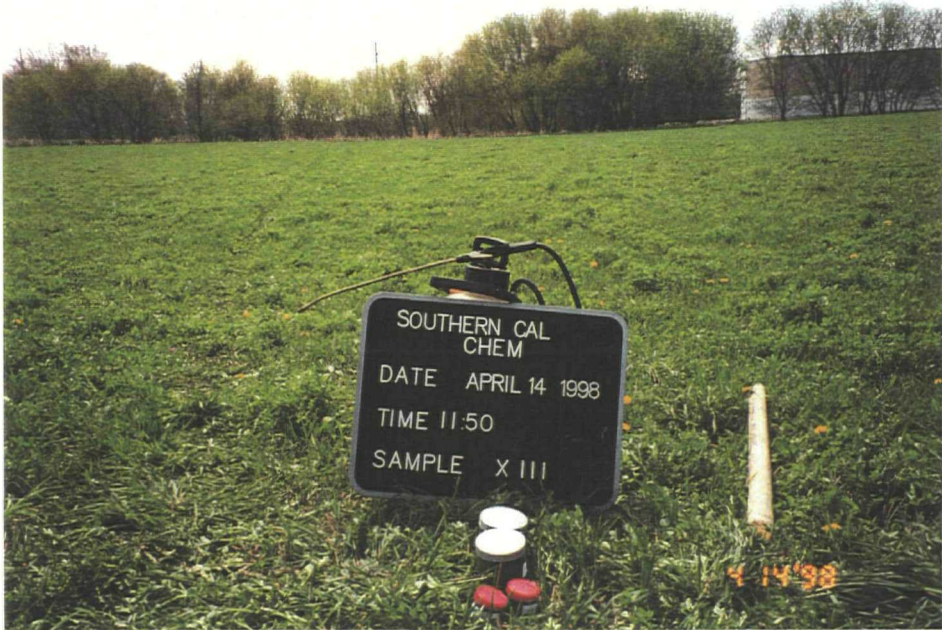
COMMENTS: Picture taken toward: South.	
Photo Number 7.	
Sample X111 was collected at a depth of 7.5 to 8.5 feet of coarse sand and gravel.

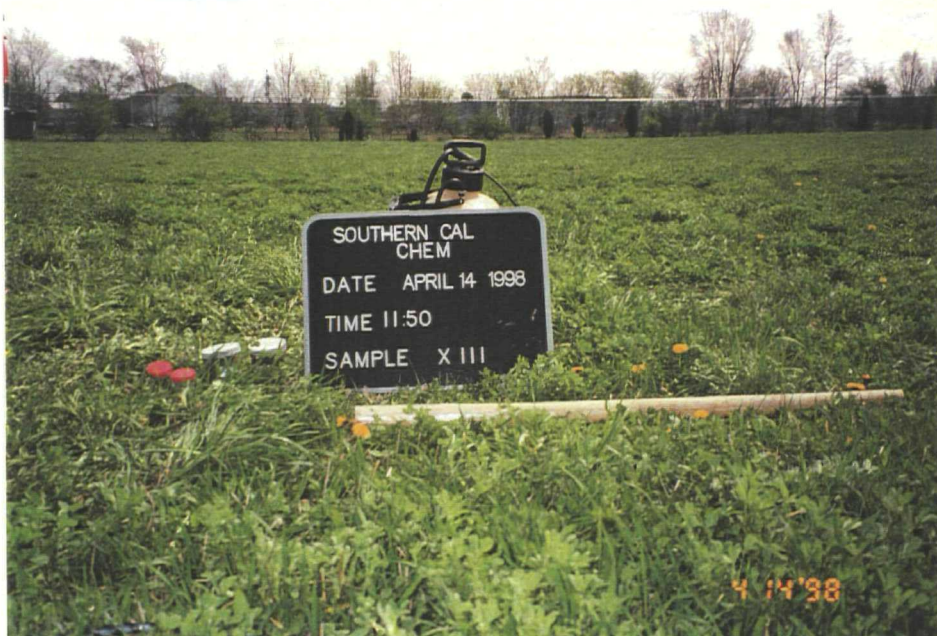
DATE: 4-14-98
TIME: 11:50
PHOTOGRAPH TAKEN BY: R. CASPER
COMMENTS: Picture taken toward: East.
Photo Number 8.
Sample X111. The Techalloy facility can be seen in the background . The field also belongs to Techalloy.

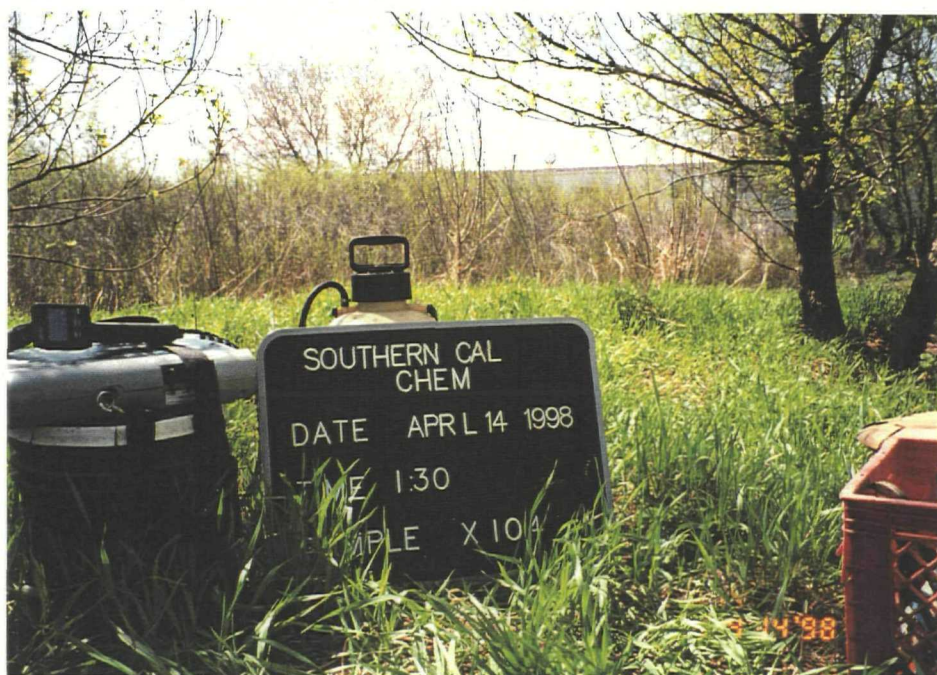
Photo Number 9.

Sample X104 was  
collected in the  
Techalloy hay  
field at a depth  
of 8 to 9 feet.

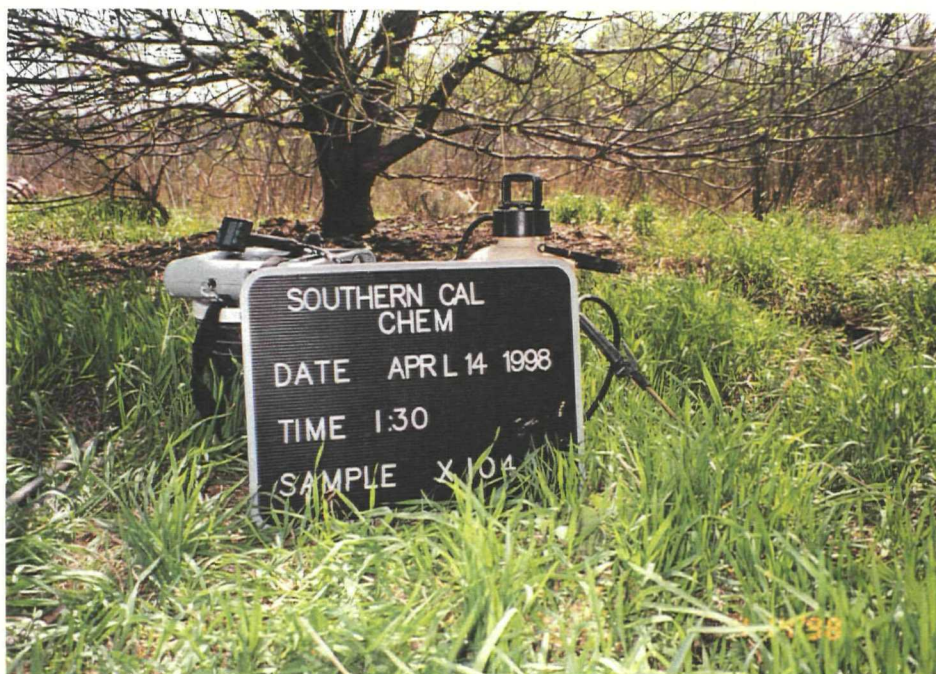
Photo Number 10.

X104 consisted of  
a dark brown med-  
ium to coarse sand  
and gravel.

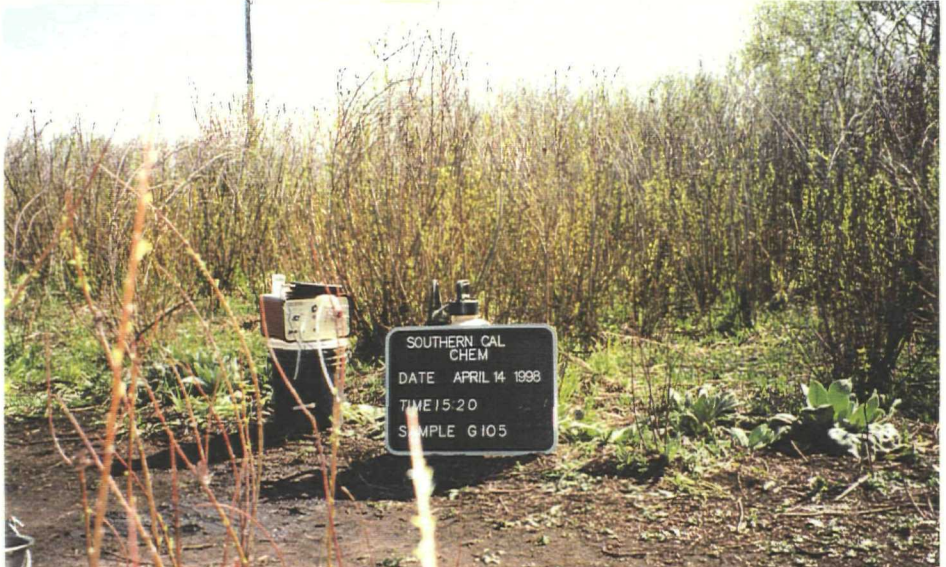
COMMENTS: Picture taken toward: South.	
Photo Number 11.	
Sample G105 was collected at a low area in the thicket east of the Bar-B-Q Co.

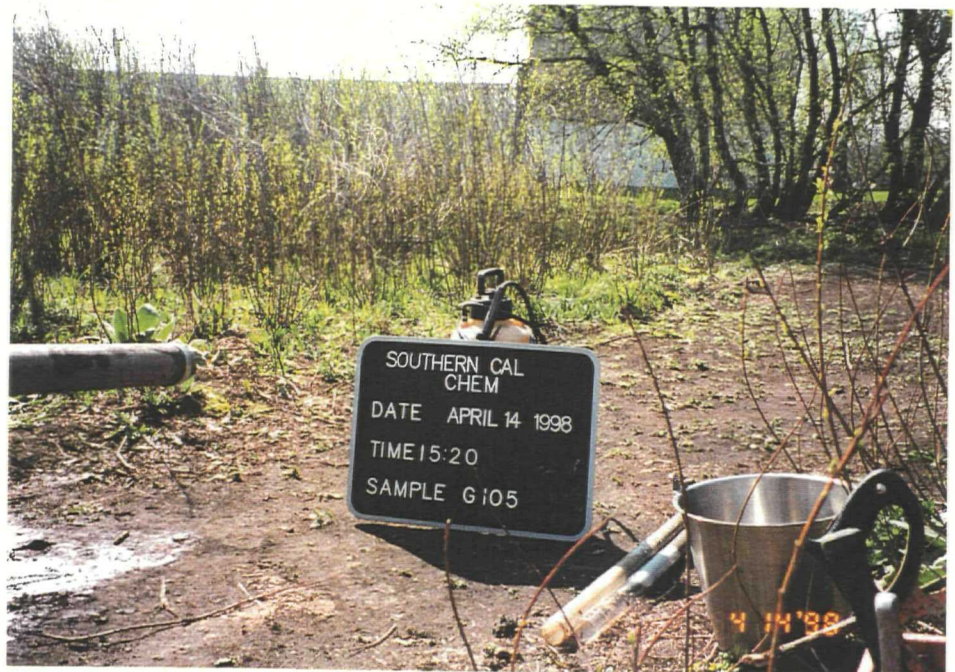
DATE: 4-14-98
TIME: 15:20.
PHOTOGRAPH TAKEN BY: R. CASPER
COMMENTS: Picture taken toward: West.
Photo Number 12.
G105 Collected at a screened depth of 9 to 10 feet at same location as X109.

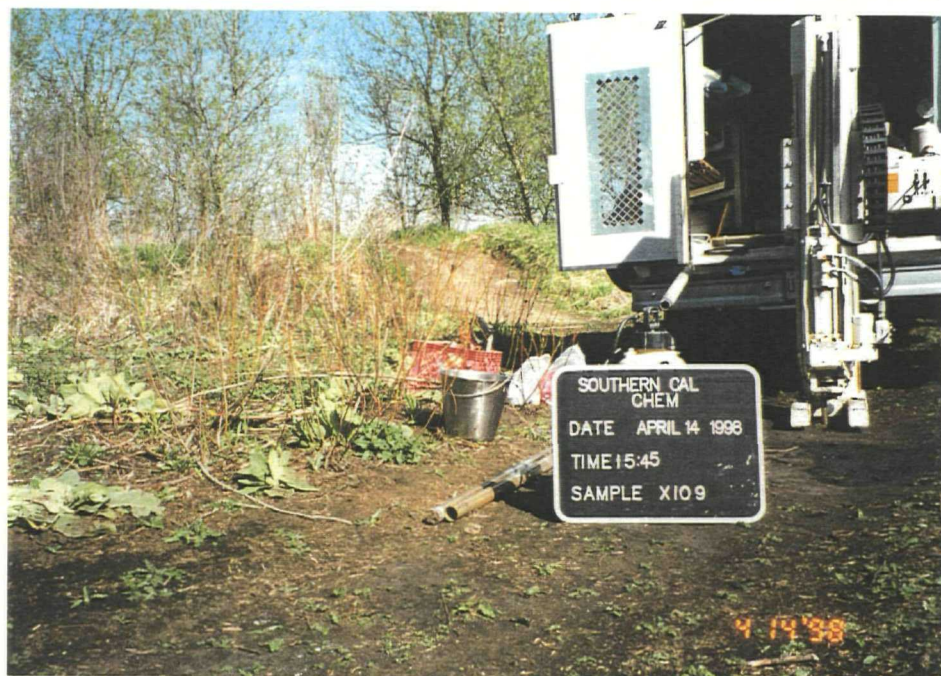
DATE: 4-14-98
TIME: 15:45
PHOTOGRAPH TAKEN BY: R. CASPER
COMMENTS: Picture taken toward: East.
Photo Number 14.
The area had piles of dirt that were used by people as ramps for motor bikes.

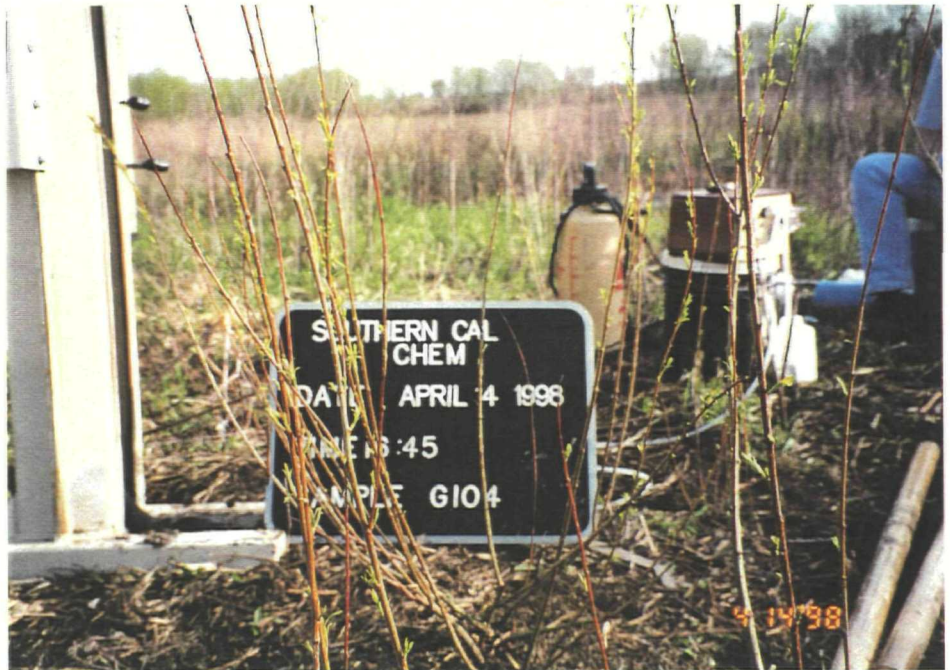
Photo Number 15

Sample G104 was  
collected at the  
north side of the  
dump area at a  
depth of 15 feet.

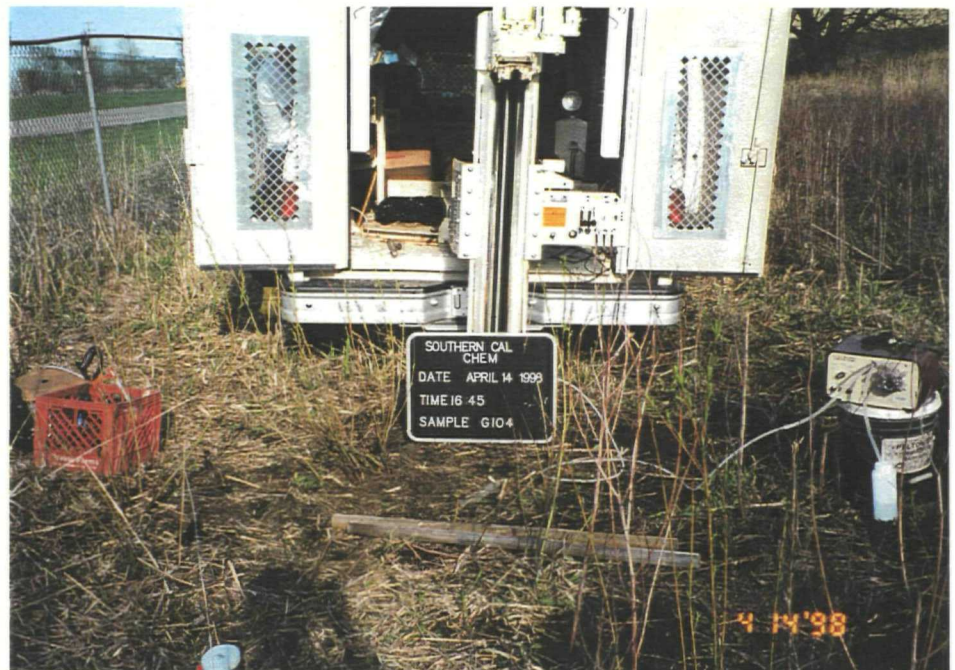
Photo Number 16.

G104. Jefferson  
street can be  
seen beyond the  
fence at the top  
left of the photo.

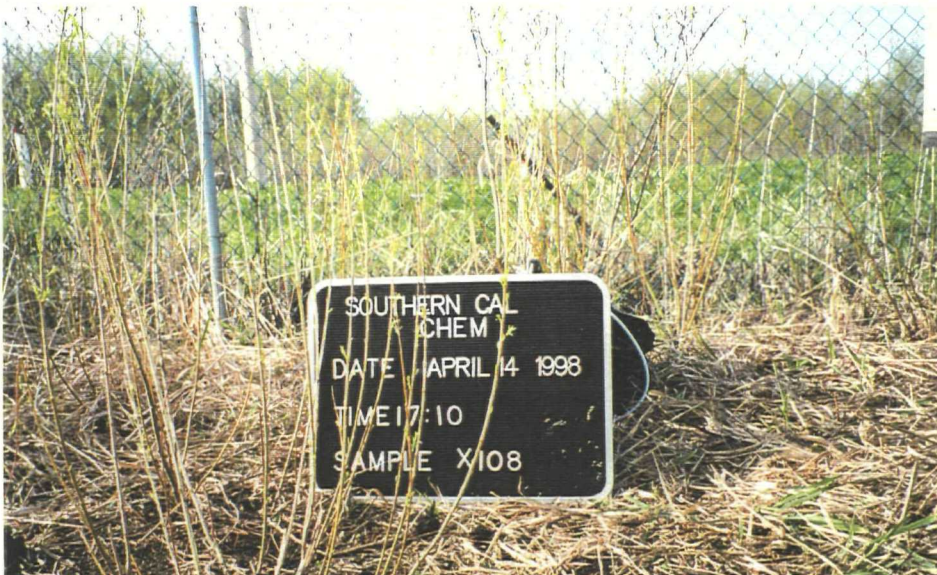
COMMENTS: Picture taken toward: North.	
Photo Number 17.	
Sample X108 was collected at the same location as	
G104 at a depth of 5 to 7 feet.

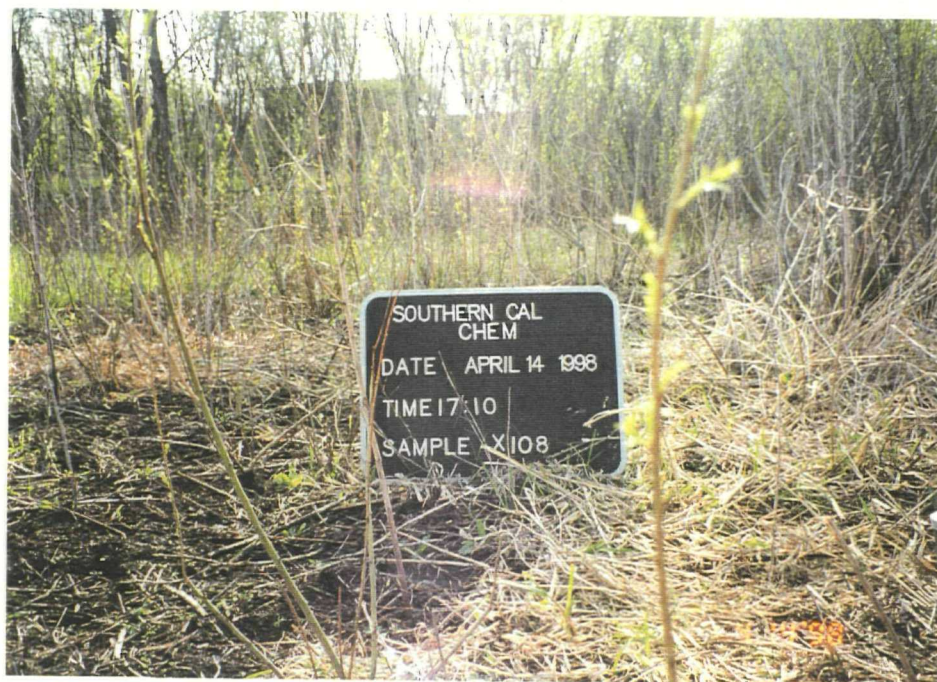
DATE: 4-14-98
TIME: 17:10
PHOTOGRAPH TAKEN BY: R. CASPER
COMMENTS: Picture taken toward: West.
Photo Number 18.
The soil sample consisted of a brown-grey medium sand.

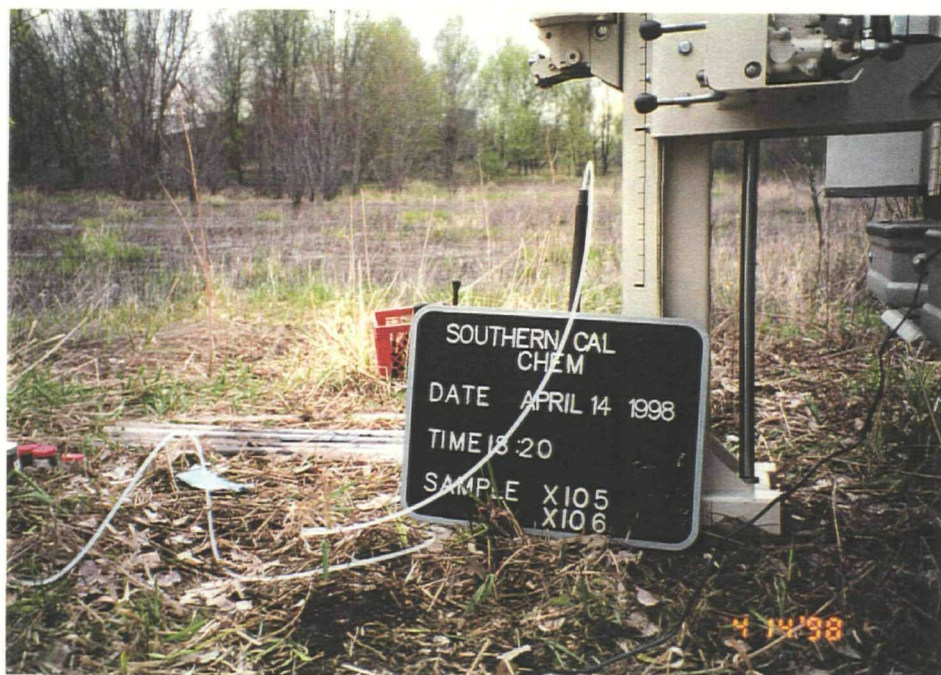
PHOTOGRAPH TAKEN BY: R.Casper
COMMENTS: Picture taken toward: West.
Photo Number 21.
Sample X105 and duplicate X106 was collected at a depth of 4 to 6 feet.

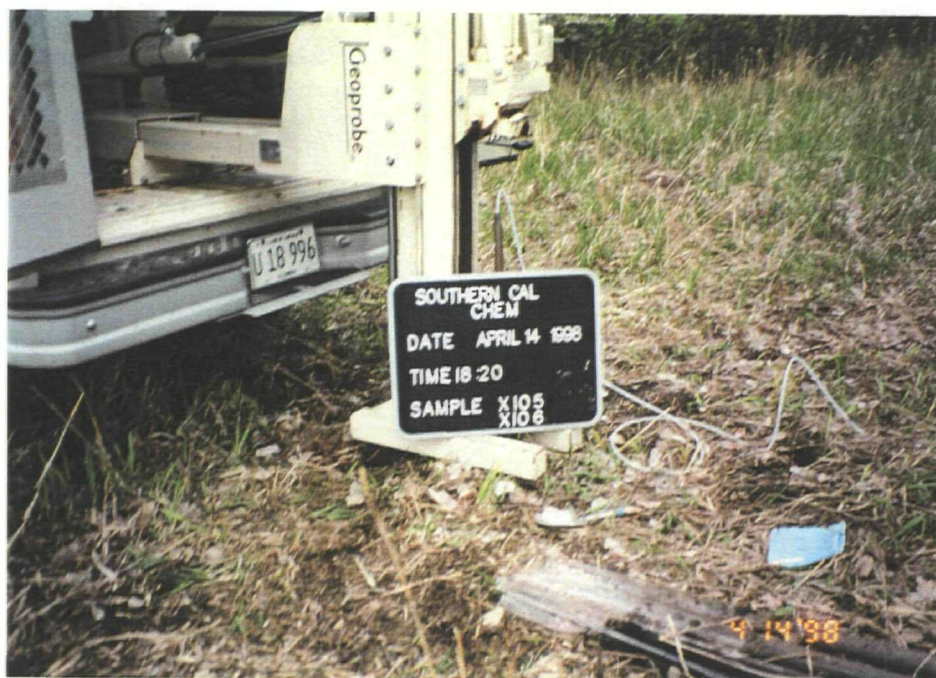
DATE: 4-14-98
TIME: 18:20
PHOTOGRAPH TAKEN BY: R. CASPER
COMMENTS: Picture taken toward: East.
Photo Number 22.
X105/X106 soil sample consisted of a brown-grey clay.

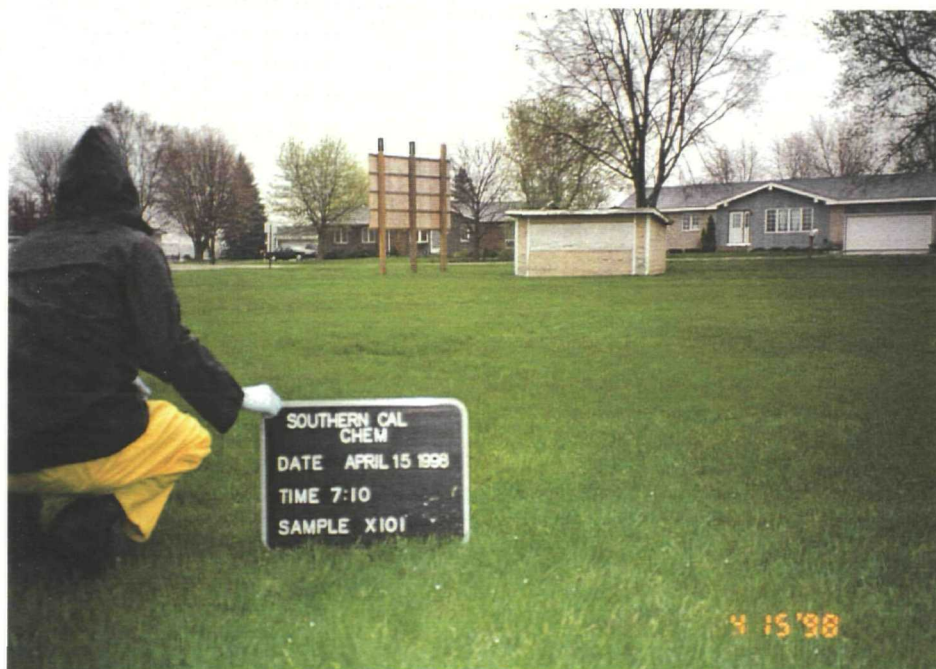
DATE: 4-15-98	SITE ILD#: 059483081 COUNTY: Mc Henry
TIME: 7:10	SITE NAME: S. California Chemical
PHOTOGRAPH TAKEN BY: R.Casper	
COMMENTS: Picture taken toward: East.	
Photo Number 23.	
Background sample X101 was collected at Union Park at a depth of 0 to 3 inches.

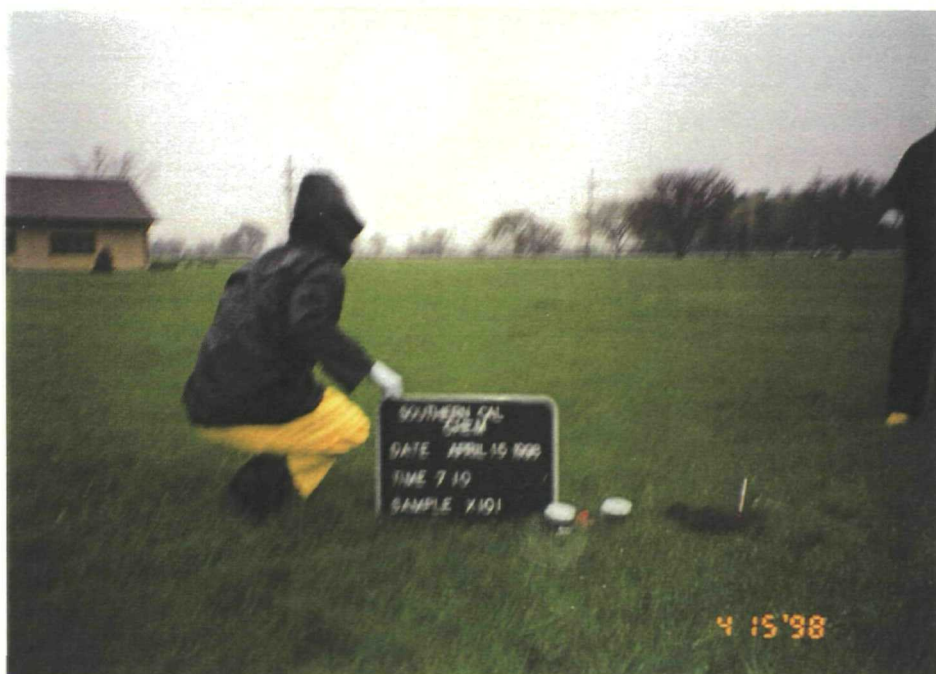
DATE: 4-15-98
TIME: 7:10
PHOTOGRAPH TAKEN BY: R. CASPER
COMMENTS: Picture taken toward: North.
Photo Number 24.
Union Park is one-half mile north-west of the site.
Sample was a black soil.

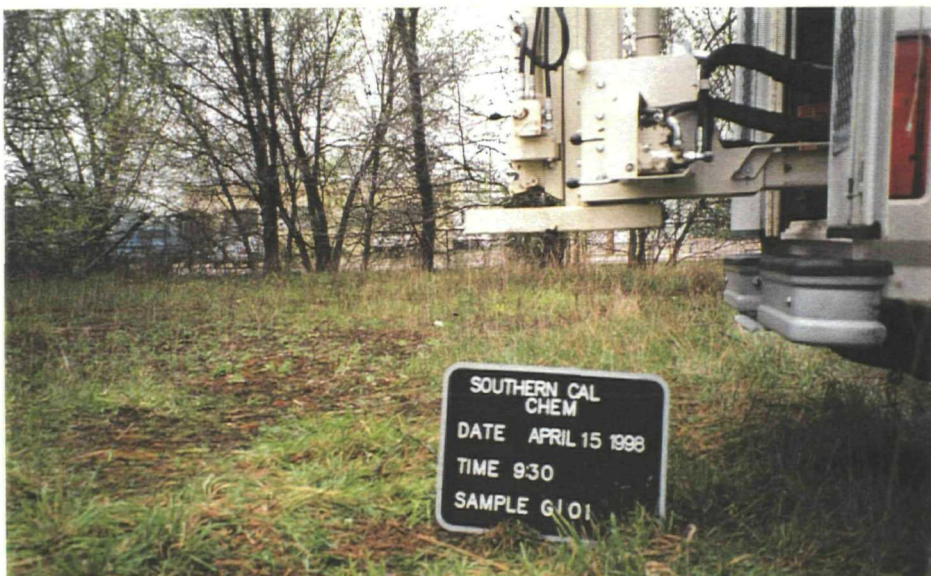
COMMENTS: Picture taken toward: East.	
Photo Number 25.	
Sample G101 was collected in the dump area at a depth of 17 feet.

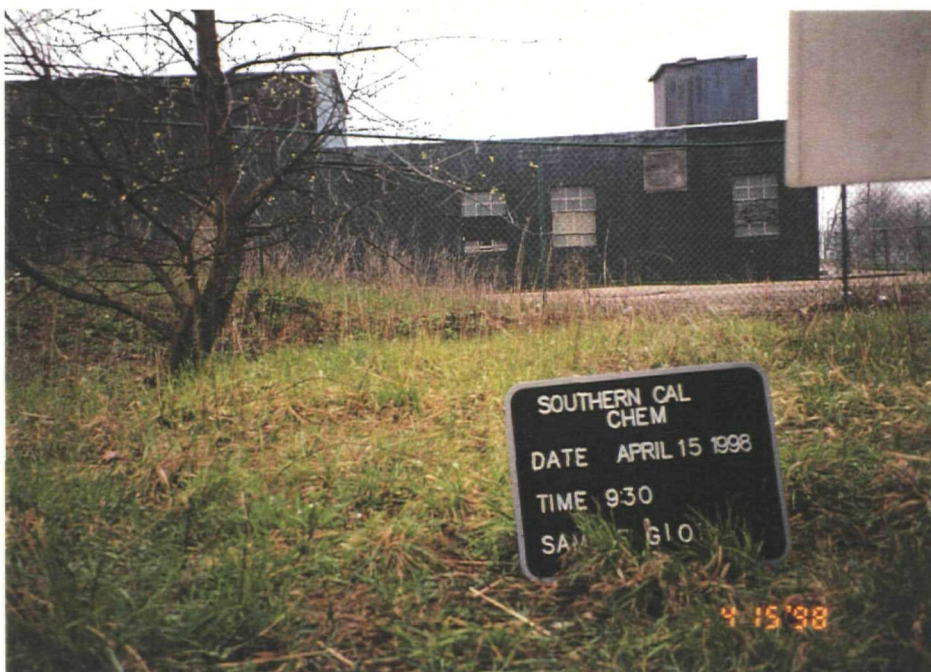
DATE: 4-15-98
TIME: 9:30
PHOTOGRAPH TAKEN BY: R. CASPER
COMMENTS: Picture taken toward: North.
Photo Number 26.
G101. The Southern California plant is the blue build- ing in the back- ground.

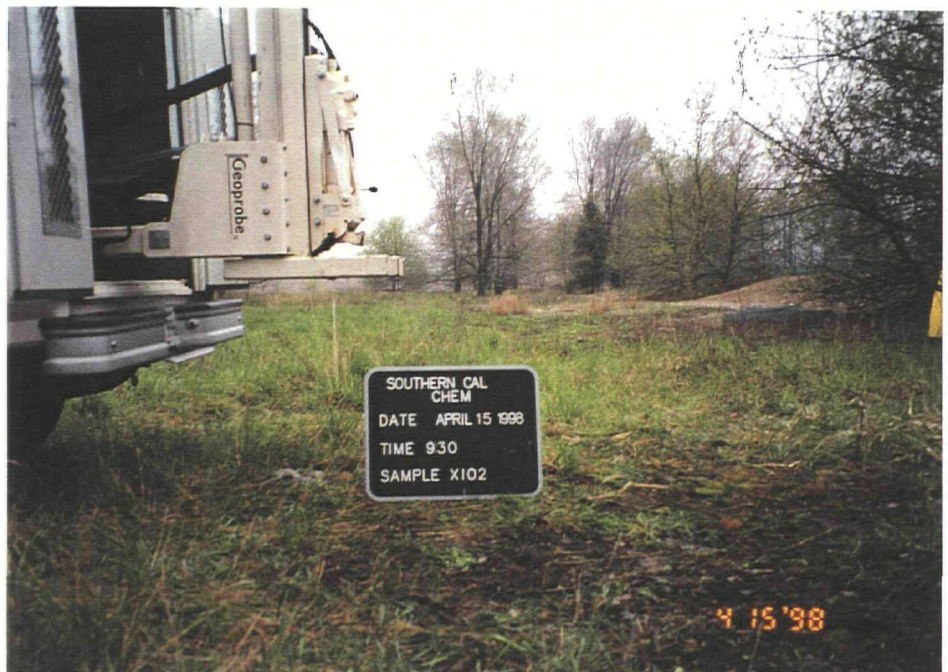
DATE: 4-15-98
TIME: 9:30
PHOTOGRAPH TAKEN BY: R. CASPER
COMMENTS: Picture taken toward: South.
Photo Number 28.
X102 consisted of fill material from the dump area.

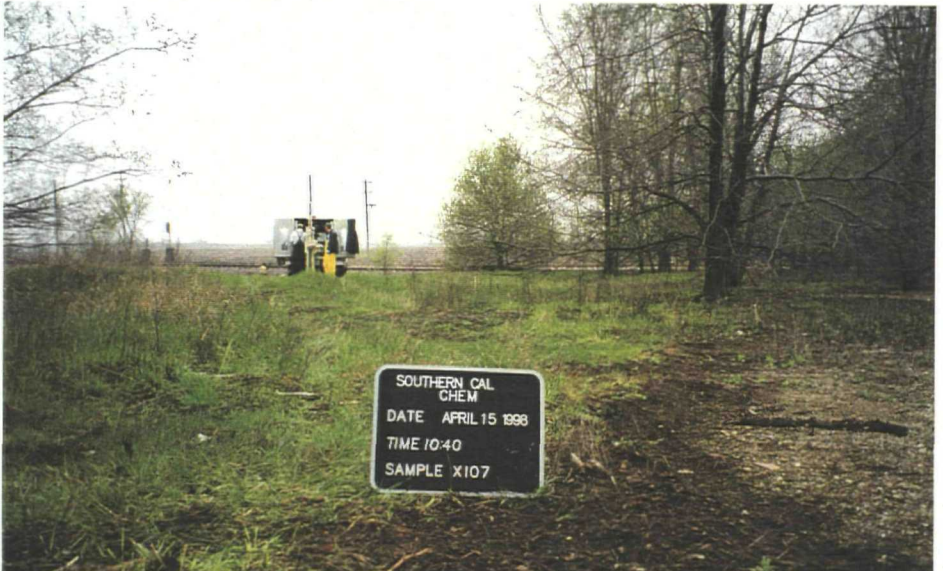
COMMENTS: Picture taken toward: South.	
Photo Number 29.	
Sample X107 was collected in the dump area at a	
depth of 8 feet.

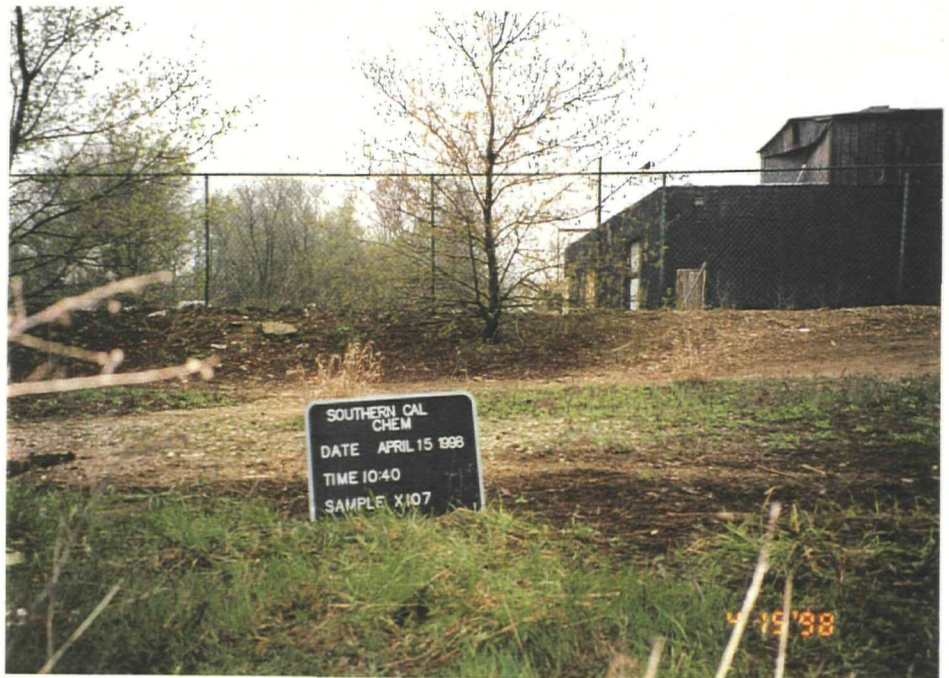
DATE: 4-15-98
TIME: 10:40
PHOTOGRAPH TAKEN BY: R. CASPER
COMMENTS: Picture taken toward: West.
Photo Number 30.
X107 consisted of a sandy clay. The S. California Chemical plant is in the background.

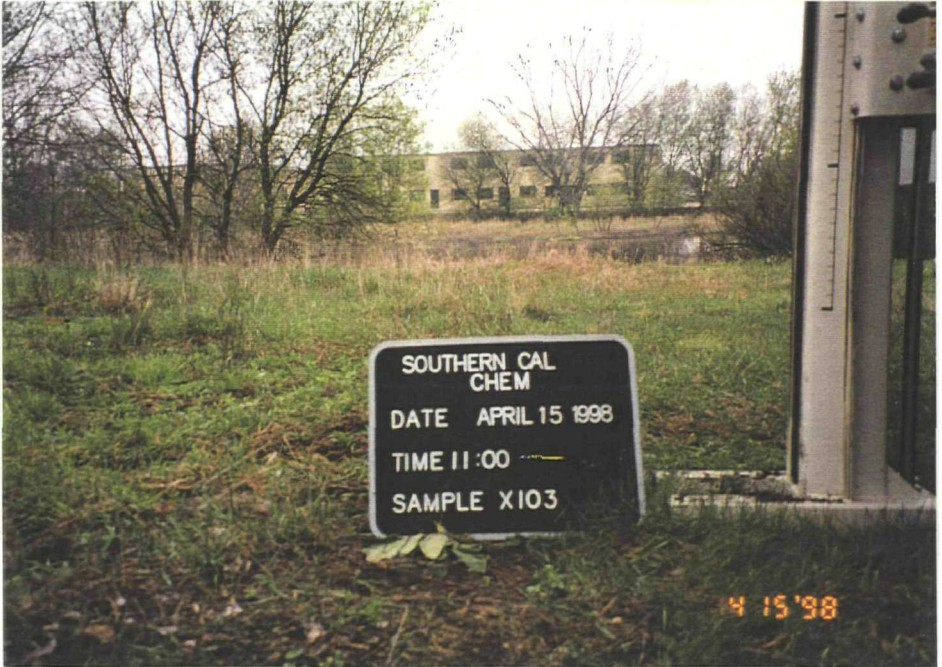
COMMENTS: Picture taken toward: East.	
Photo Number 31.	
Sample X103 was collected at 5 to 7 feet and consist ed of fill and circuit boards.

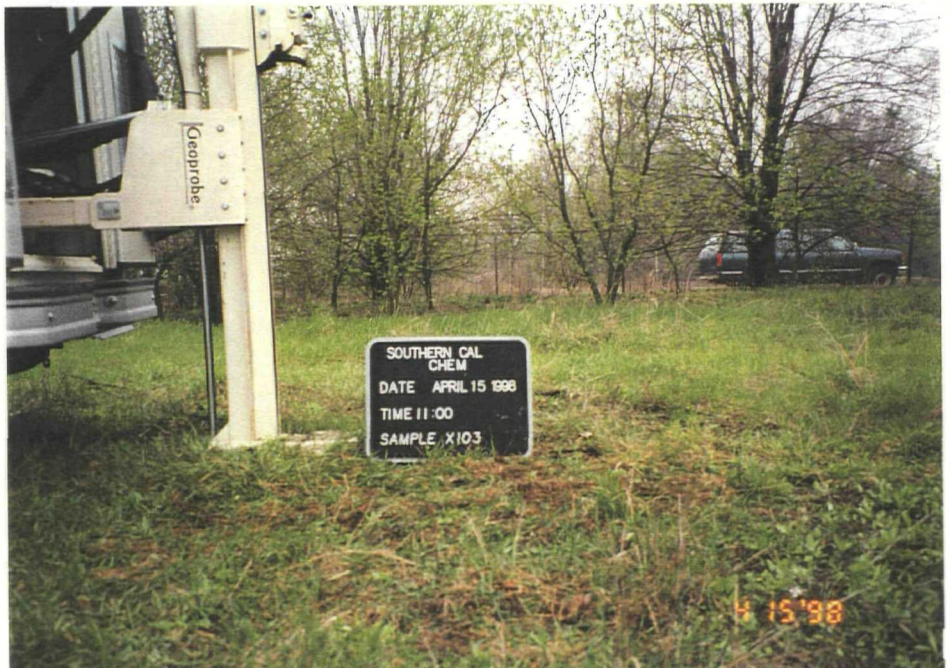
DATE: 4-15-98
TIME: 11:00
PHOTOGRAPH TAKEN BY: R. Casper
COMMENTS: Picture taken toward: West.
Photo Number 32
X103. The build- ings of S. Calif- ornia Chemical lie beyond the fence in the background.
